SEWER SYSTEM EVALUATION STUDY

City of Lawton

Sewer System Evaluation Study Report Volume I

April 1997

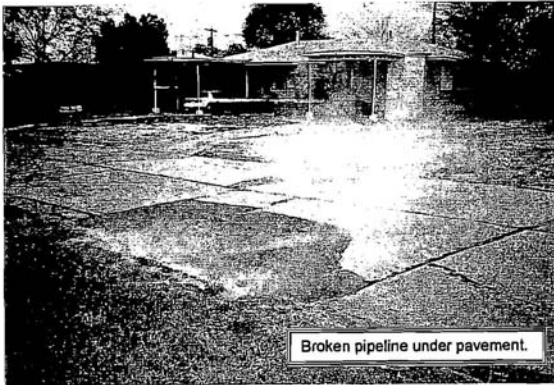
Broken pipeline under pavement.
